DEPARTMENT OF TRANSPORTATION

Quality Assurance and Source Inspection

Contract #: 04-0120F4Cty: SF/ALA Rte: 80 PM: 13.2/13.9File #: 69.28**WELDING INSPECTION REPORT****Resident Engineer:**Siegenthaler, Peter**Address:** 333 Burma Road**City:** Oakland, CA 94607**Report No:** WIR-022051**Date Inspected:** 12-Mar-2011**Project Name:** SAS Superstructure**OSM Arrival Time:** 700**Prime Contractor:** American Bridge/Fluor Enterprises, a JV**OSM Departure Time:** 1900**Contractor:** Zhenhua Port Machinery Company, Ltd (ZPMC), Changxing Island **Location:** Shanghai, China**CWI Name:** Lv Li Qing**CWI Present:** Yes No**Inspected CWI report:** Yes No N/A**Rod Oven in Use:** Yes No N/A**Electrode to specification:** Yes No N/A**Weld Procedures Followed:** Yes No N/A**Qualified Welders:** Yes No N/A**Verified Joint Fit-up:** Yes No N/A**Approved Drawings:** Yes No N/A**Approved WPS:** Yes No N/A**Delayed / Cancelled:** Yes No N/A**Bridge No:** 34-0006**Component:** OBG**Summary of Items Observed:**

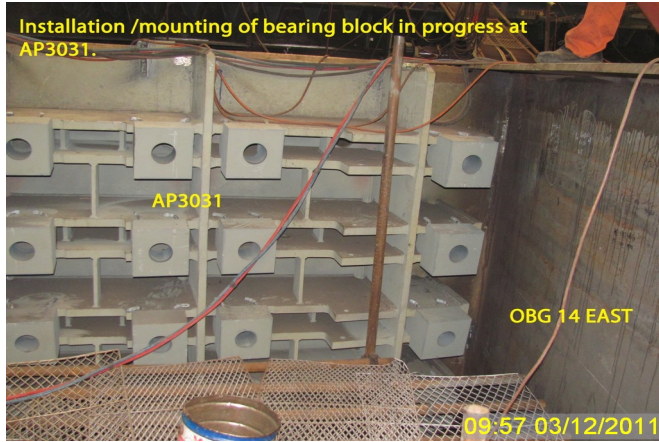
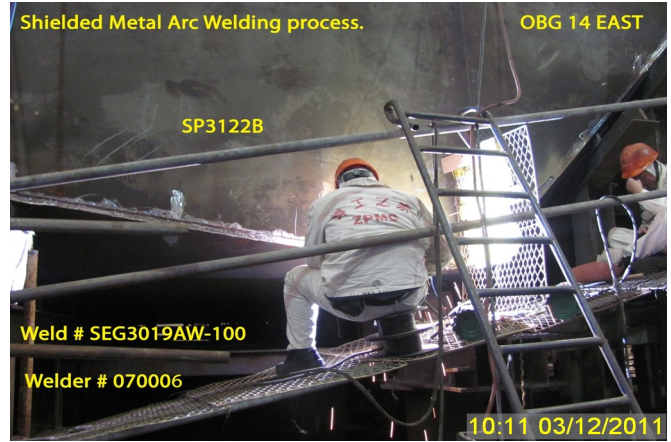
This QA Inspector observed installation /mounting of bearing block in progress at AP3031.

This Quality Assurance (QA) Inspector observed ZPMC personnel performing heat straightening, member identified as Anchor plate AP3004. Distortion appeared to be caused by welding. Weld number identified as SEG3019X-004~009. ZPMC Quality Control (QC) inspector identified as Mr. Zhong Guo Hui was present to monitor the heat straightening process. The heat straightening appeared to comply with heat straightening Report HSR1 (B)-10173.
